INVENTORY OF
SIGNIFICANT
STRUCTURES
ARCHITECTURAL CHARACTER GUIDELINES

SEQUOIA &
KINGS CANYON
NATIONAL
PARKS

Laura Soullière Harrison
Architectural Historian
National Park Service
Southwest Regional Office
February, 1989

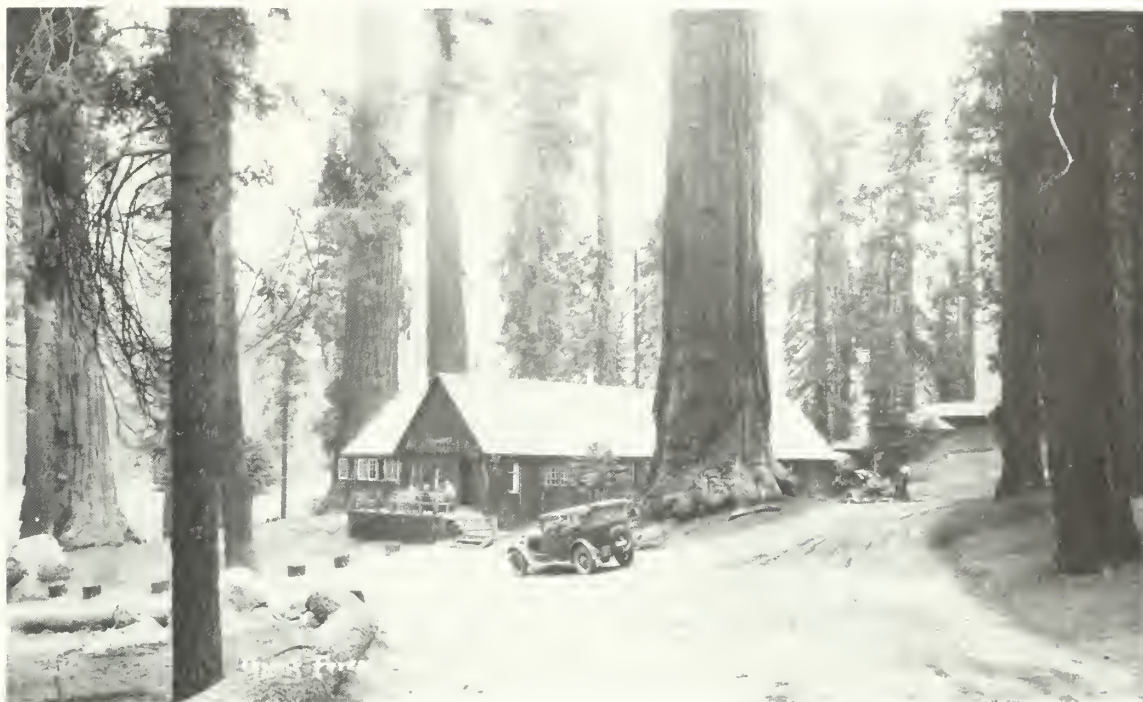
The main building of Giant Forest Lodge (circa 1920) sported a shake roof and Sequoia bark siding. The bright green paint around the window frames and mullions duplicated the green lichen that frequently appeared on adjacent fir trees. Although this building had a simple, functional form, its exterior materials tied the building with its setting.

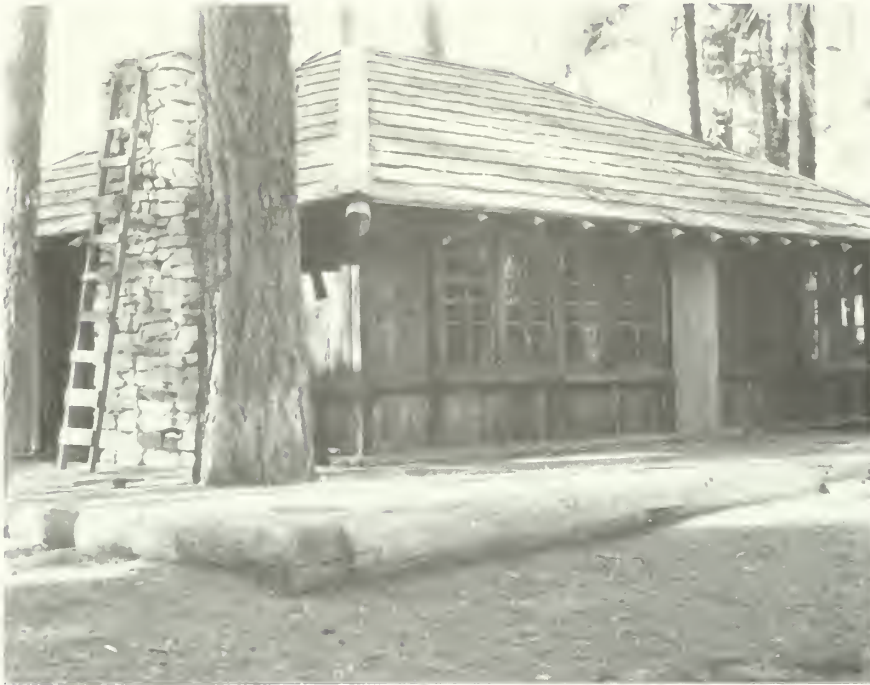
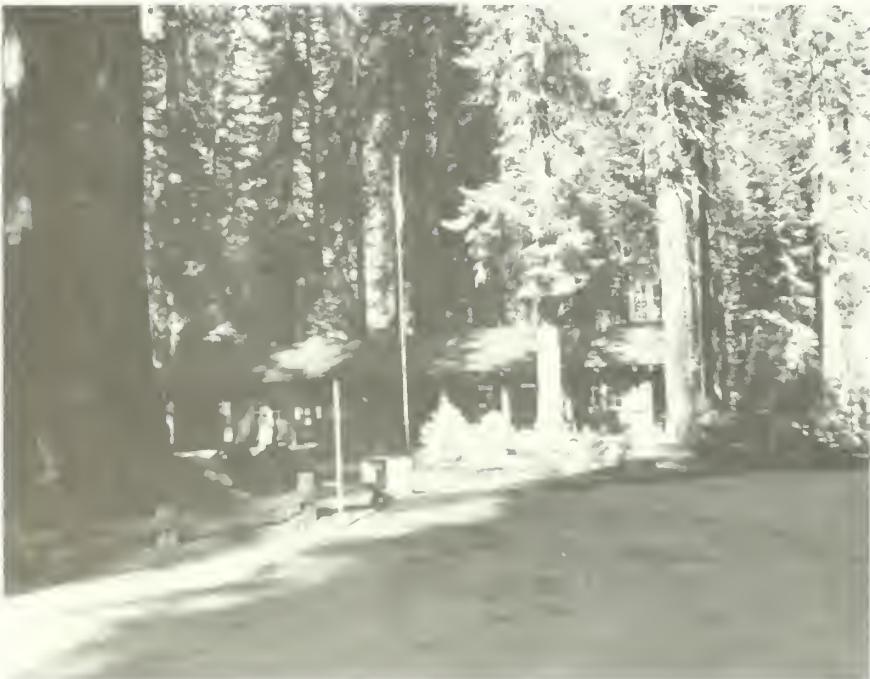
In the early 1920s the National Park Service established a strong physical presence in Giant Forest. The superintendent's residence (above) and the Giant Forest museum (below) established the agency's architectural direction. Hewn timber frames separated wall areas of sequoia-bark infill. Rubble masonry chimneys added to the buildings' rustic character. Exposed-frame construction continued in popularity through the 1960s. Post-World War II construction, however, lacked the strength of character that the earlier buildings possessed.

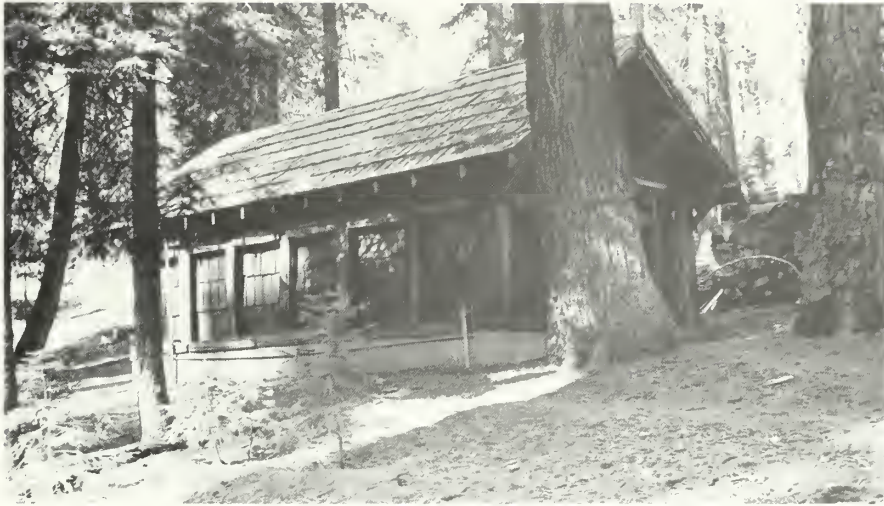
A simple style developed for utilitarian Park Service structures such as this comfort station in Giant Forest. Following the rustic pattern established by the earlier Park Service buildings in Giant Forest, the exposed framing defined the building's edges and structure. The shake infill added the rough texture equivalent to the roughness of the surrounding trees.

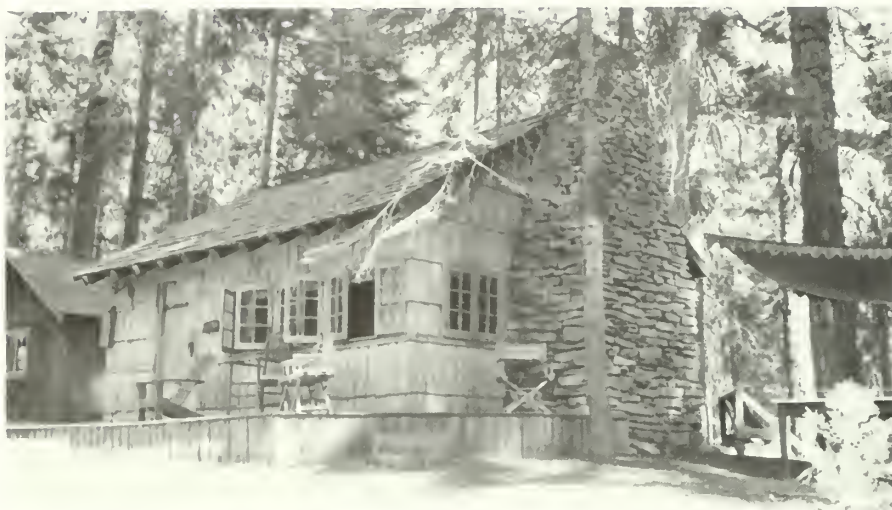
In 1921 the concessions operation constructed this rustic cabin as the writing room for guests of Giant Forest Lodge. The gentle batter of the chimney, the rough shake exterior, the wood shingle roof, and the wrought-iron hinges contributed to the structure's rusticity. Architect Herbert Maier, who later designed a number of National Park museums and influenced the designs of hundred CCC structures, designed this building.

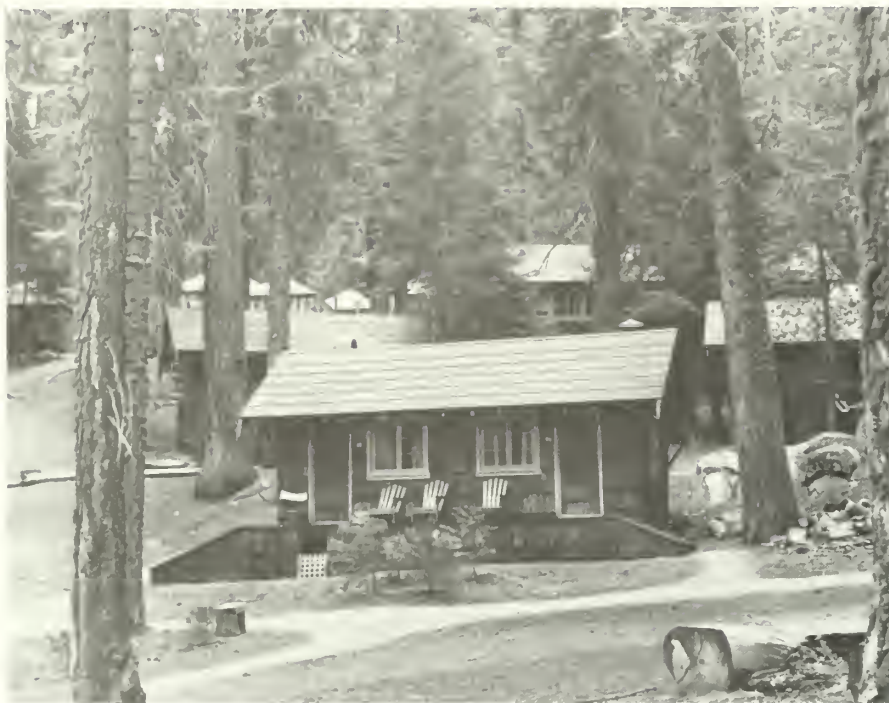
The concessioner offered a variety of overnight accommodations in Giant Forest. The small duplexes (above) dated from 1921. Their shake exteriors, lichen-green trim, wood-shingled roofs, and wrought-iron door hardware were carefully repeated in cottage after cottage. Architect Herbert Maier designed these buildings. The cleaner lined cottages of the mid-1930s (below) had enough architectural variety to defy boredom. Vertical siding defined the corners. Horizontal siding covered the remaining wall spaces. The shingle pattern added even more texture.

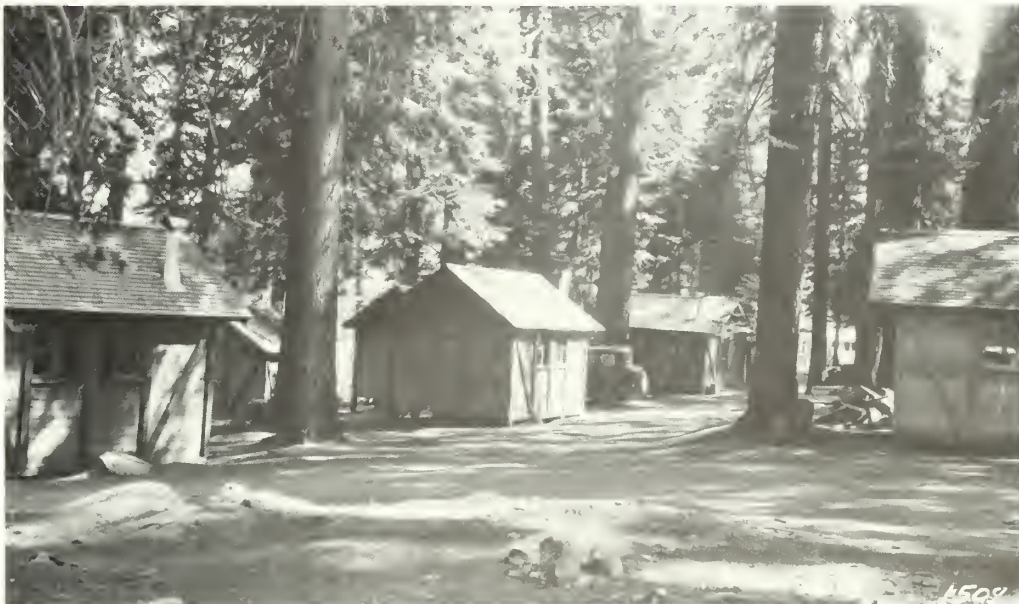
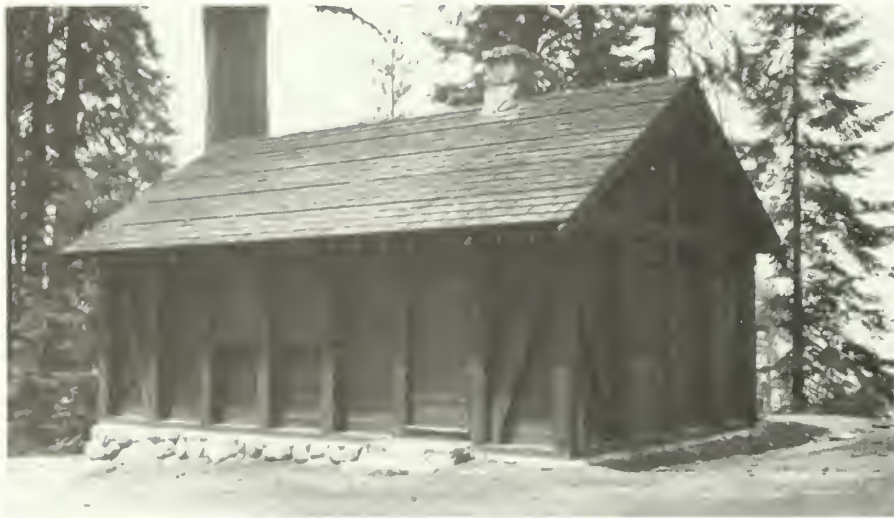
During the 1930s the six-year plans for Lodgepole and Giant Forest called for buildings with "heavy frame type" construction such as that seen here in the Last Hill dormitory. The rubble-veneer foundation, thick structural members, and roof shingling pattern developed into a consistent style for comfort stations and small utilitarian structures.

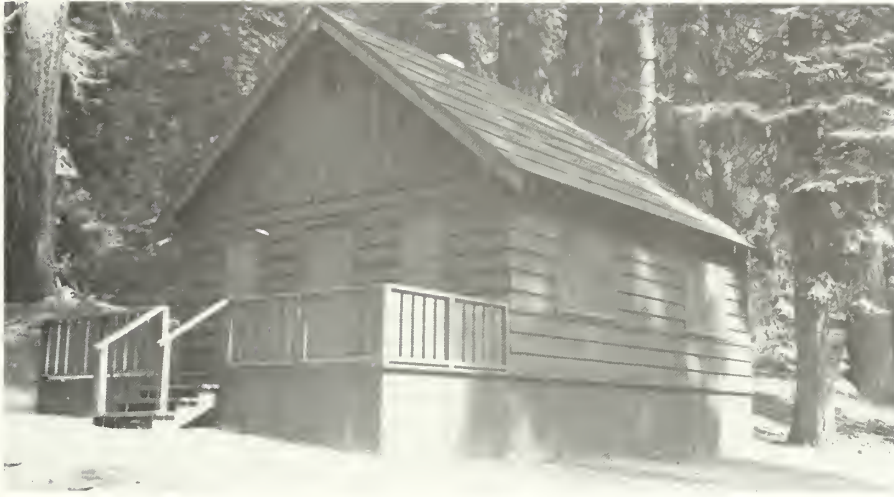
Other buildings at the 7,000-foot elevation possessed a decidedly rustic air. The vertical board-and-batten siding in the gable ends provided a counterpoint to the wide, horizontal boards of the principle siding. The buildings possessed both style and practicality. Above is B-89, a seasonal residence at Wolverton. Below is the Lodgepole Fire Dormitory.

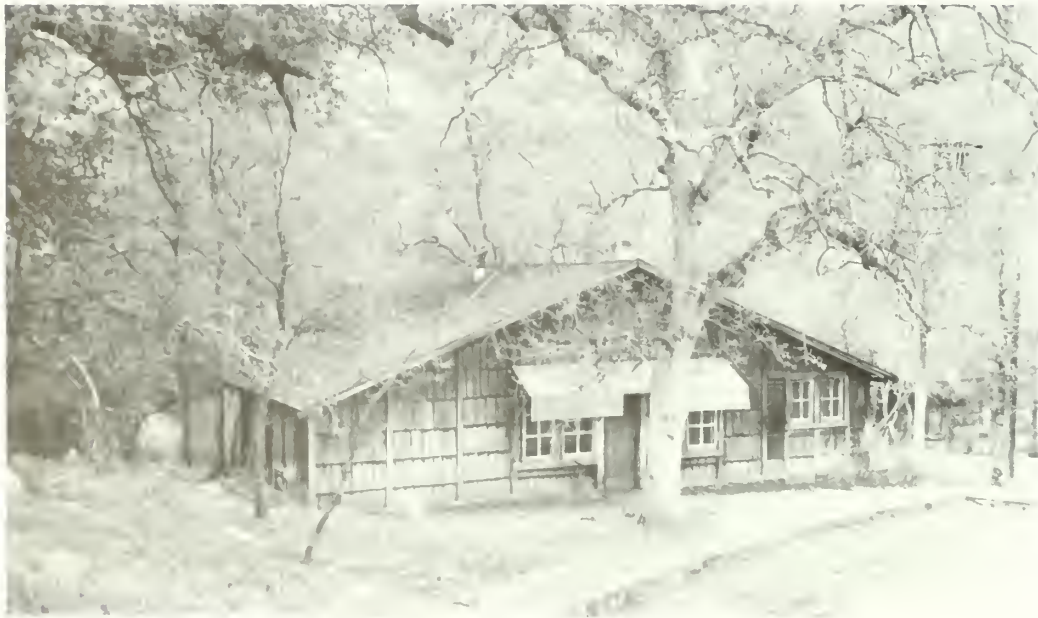
During the mid-1930s the Branch of Plans and Design chose Spanish-Californian architecture as its design theme for Ash Mountain. The only building constructed entirely in this style, however, was the Superintendent's residence. Funding restraints probably limited the finer details such as the tile roofs on other residences. Wood shingles were a considerably cheaper material. By 1940 all new residences in Ash Mountain were constructed with stucco-finished exterior walls and asbestos-shingled roofs. Concern over fireproofing brought about these changes.

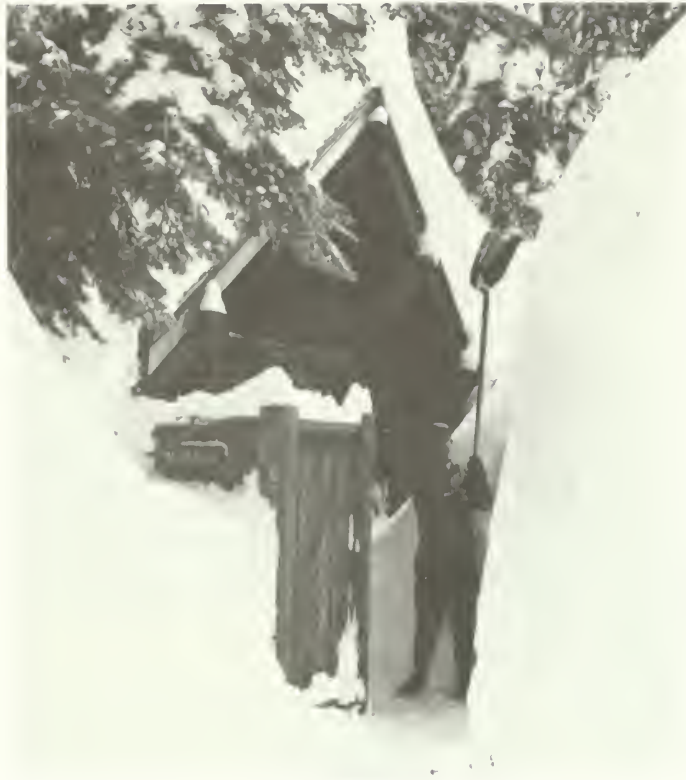
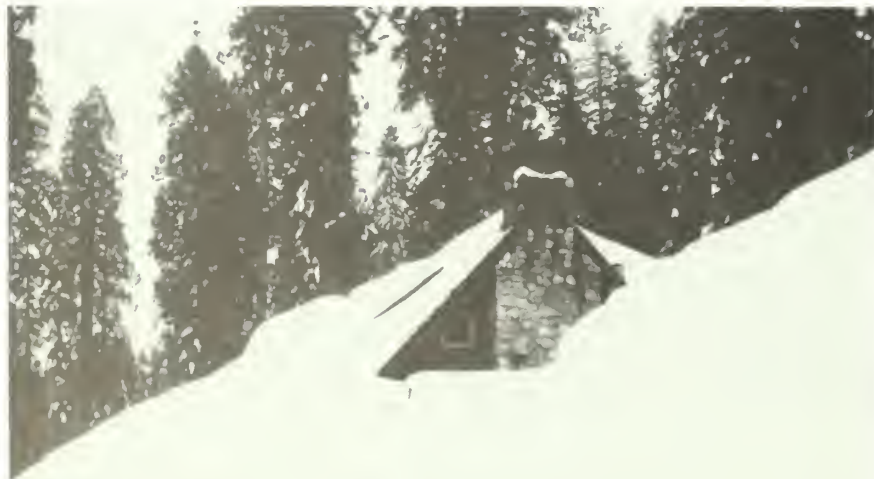
Heavy snows have caused considerable stress to buildings in the higher elevations. In 1952 (above), 1969 (below), and 1983, record snows buried buildings under tons of snow.

The buildings at the higher elevations continued to face the ravages of nature. The harshness of winter storms was often severe. A look at some of the winter storms of the past revealed that enormous amounts of precipitation fell in very short periods of time and caused considerable damage to buildings. During the winter of 1931-32 Judge Fry's cabin in

Giant Forest collapsed. The Swiss carpenters who constructed the cabin gave its roof a steep pitch, but the first snows turned to ice on the roofs that held on the subsequent snows. That particularly rough winter also caused the collapse of the General Grant Park Lodge and thirty-seven privately owned houses at Wilsonia.¹⁵ In May, 1968, snow collapsed the maintenance shed at Lodgepole.¹⁶

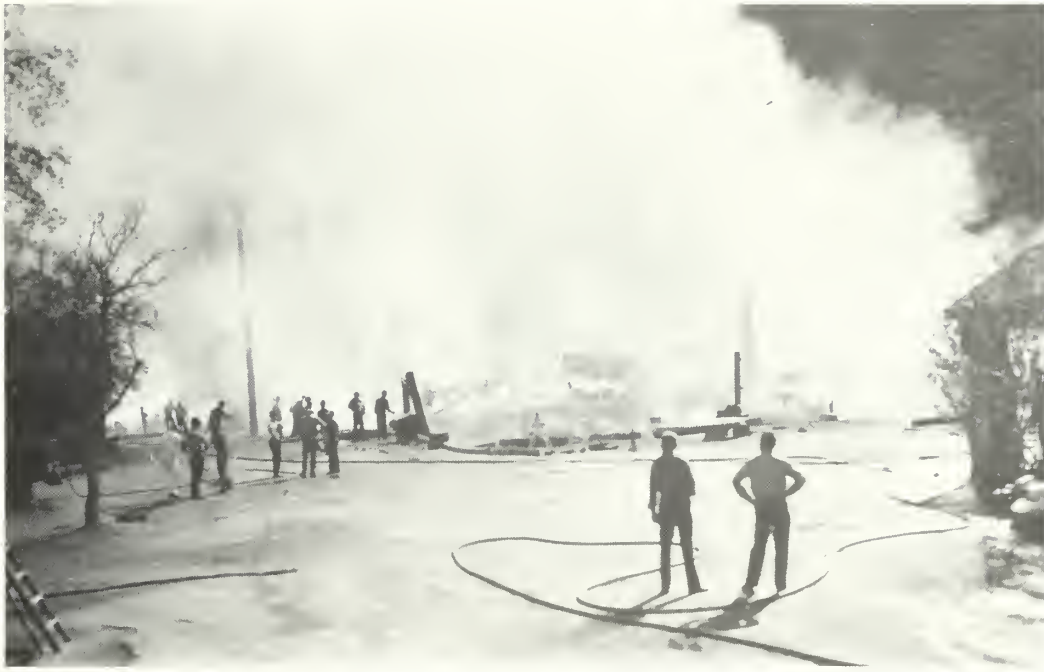
The Ash Mountain fire of November 11, 1939 destroyed several maintenance buildings and could have taken most of the woodframe headquarters development with it. Luckily conditions for spread of fire were minimal on that day. Even so, the hot drafts from the fire blew roof shingles a mile away. As a result of this fire, all new construction in Ash Mountain had to be fireproof.

I think it essential that we cease immediately the construction of buildings in the Ash Mtn. area consisting of shake sidewalls and shingles on the roof. We found large quantities of partly burned shakes and shingles as much as a mile away from Ash Mtn. If conditions for spread of fire had been favorable on that particular day, the entire Middle Fork of the Kaweah River Valley would perhaps have been burned out. It is therefore recommended that all existing residence plans for the Ash Mtn. area be revised to provide for a reasonable fire resistant roof and stucco side walls.¹²

A letter to the Regional Director four months later also recommended that any maintenance buildings in Ash Mountain be constructed of reinforced concrete.¹³ Thus the preference for California cottages and wood-frame maintenance buildings succumbed to the harsher realities of nature in the Sierra foothills.

Following the change in policy concerning fire-resistant construction, the Ash Mountain buildings assumed a different look. Although the exact reason did not appear in the documents, the justification for deleting the tile roofs from the stucco residences was probably one of economics. By 1944 the General Foreman reported to the Superintendent that the two garages and four residences built in Ash Mountain since the 1939 fire had Johns Manville Cedar Grain asbestos shingle roofs and stucco exteriors. He also recommended that more of the roofs be covered with asbestos shingles.¹⁴

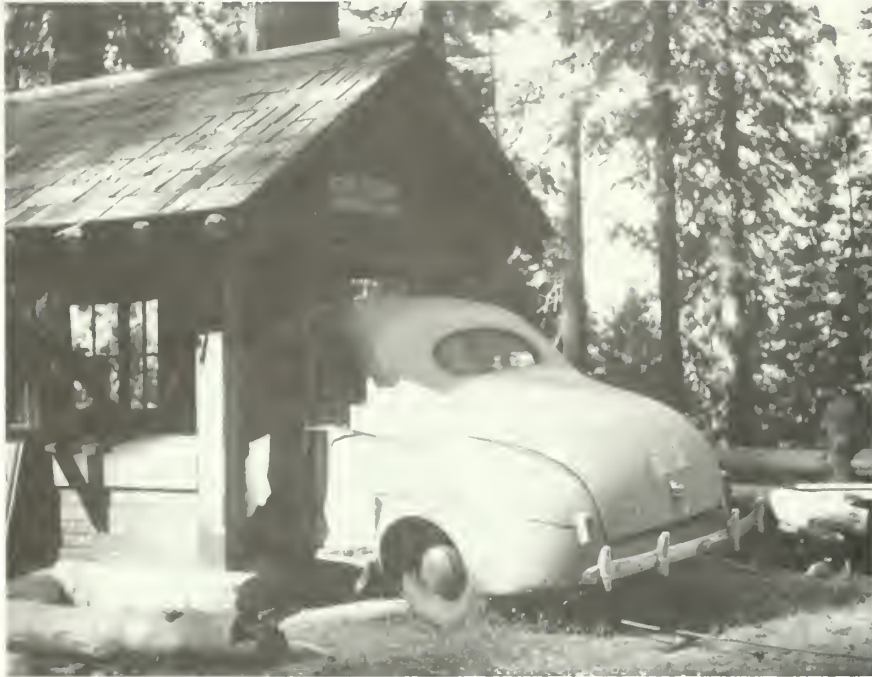
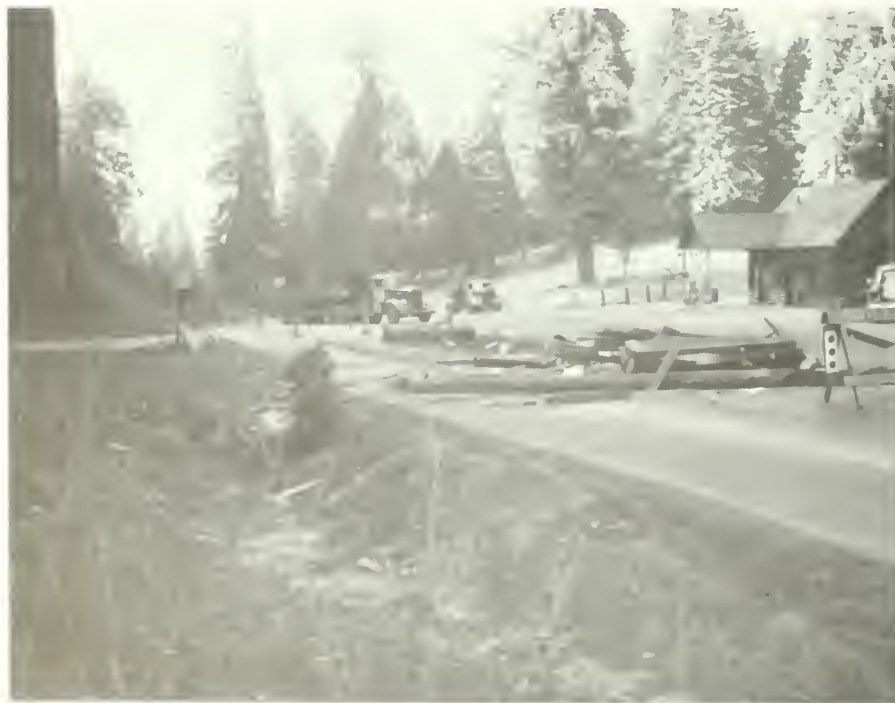
Vehicles have long been the bane of entrance stations. In 1950 the Lost Grove entrance station (above) fell victim to one. In 1957 a logging truck left only a pile of rubble where the Big Stump entrance station once stood (below).

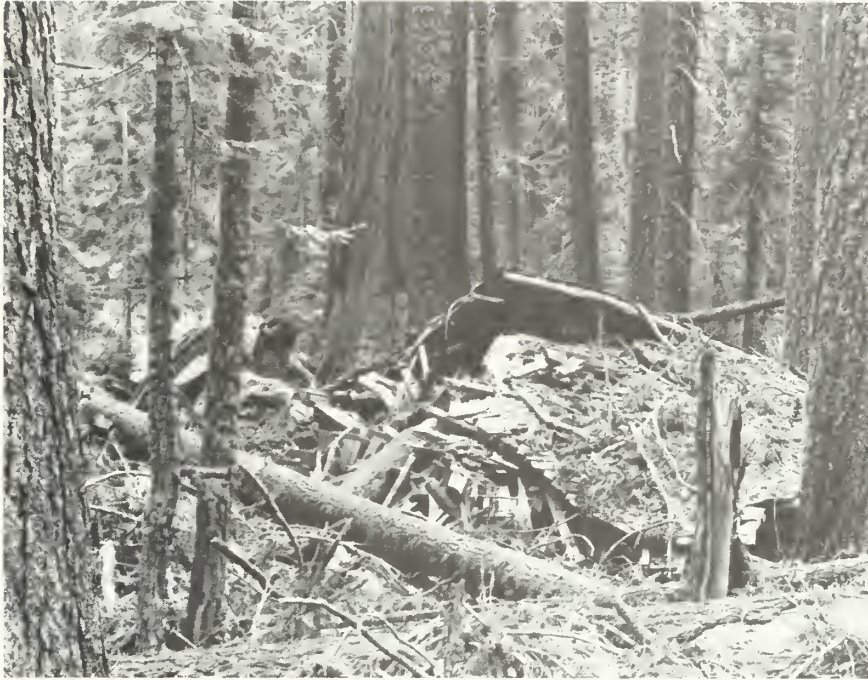
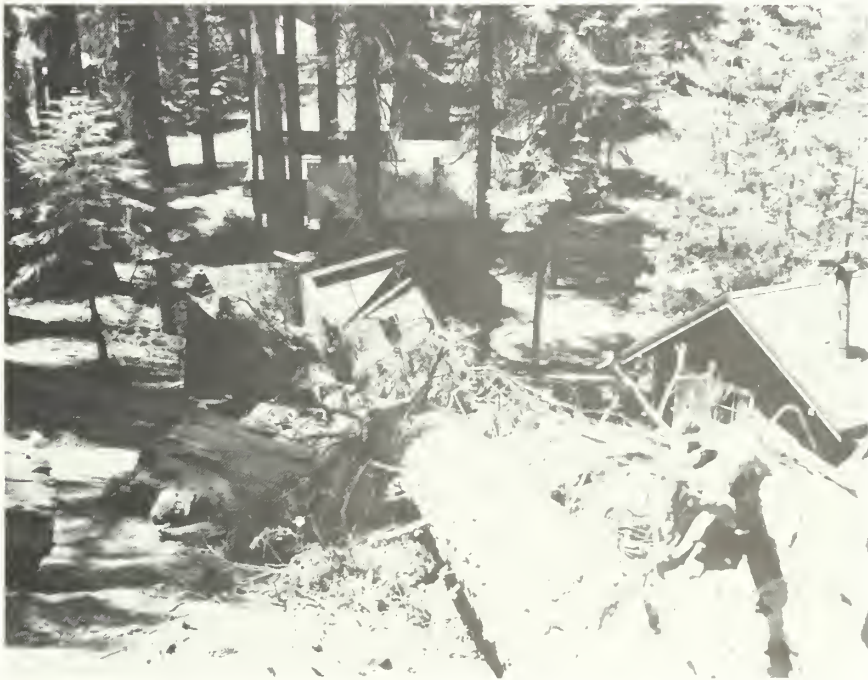
Hazard trees have destroyed a number of buildings in the parks. Both of these photographs taken in different decades in Giant Forest show the absolute destruction that a single tree can cause.

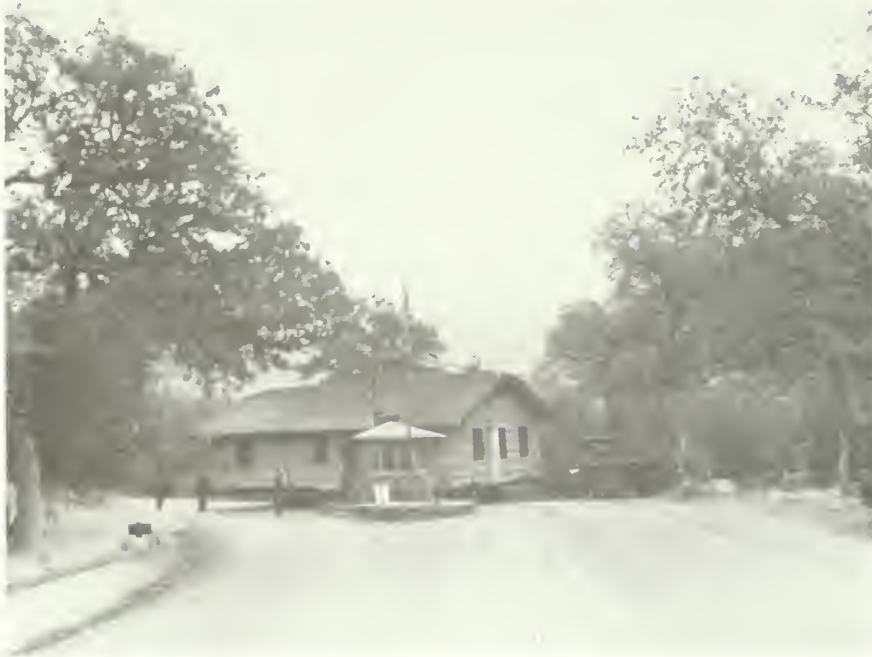
Moving buildings is a tradition in Sequoia and Kings Canyon. Among the many benefits of the post-and-block foundation is its lightness on the land. The building can be picked up easily and transported to another location. The building leaves a minimal scar.

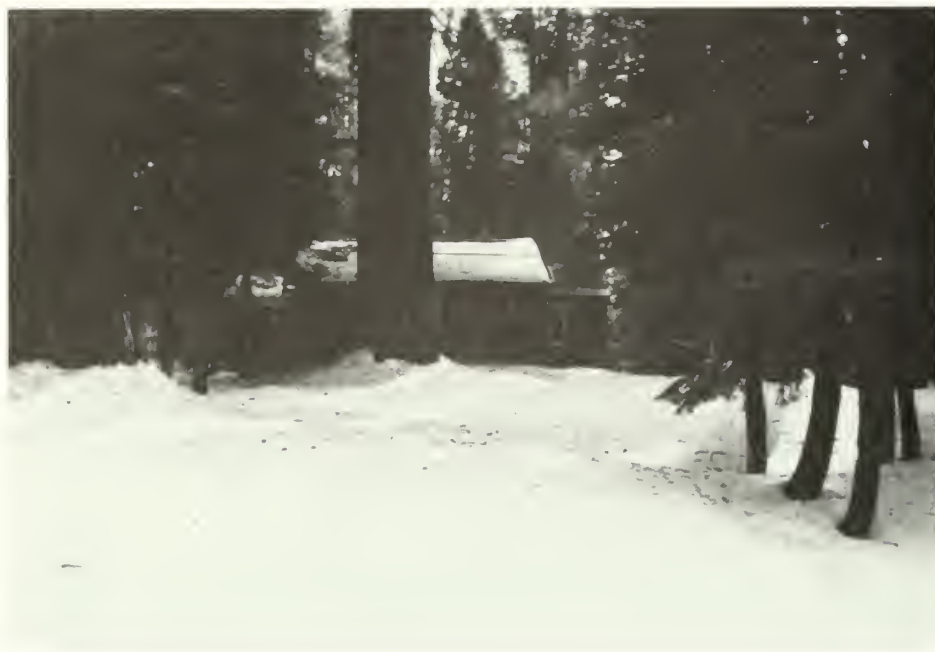
Building: Giant Forest Ranger Residence B-55

This building is a classic example of a structure built following the rustic design ethic. The building is listed on the National Register of Historic Places as part of Giant Forest Village Historic District.
